# Manhole Inspection Summary

Manhole # S45C2\_019MH

Insp Date: **12/18/07 9:11 AM**

**Location** Address: **3800 Pascal Ave**

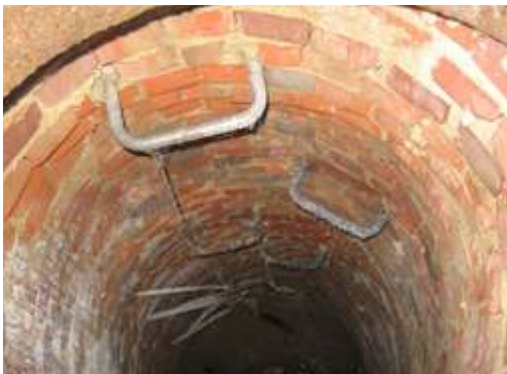
Steps

Count: **6** Missing: **0** ☐ Corroded

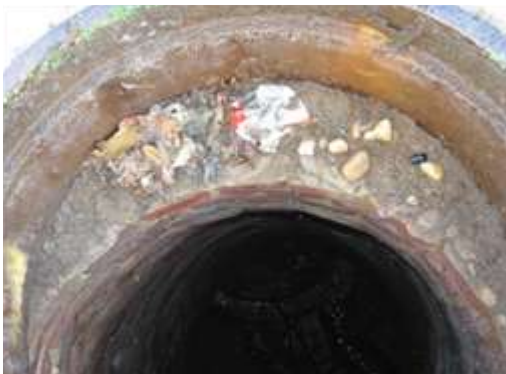
Defect 1

Offset: **5** (in.)

Frame offset

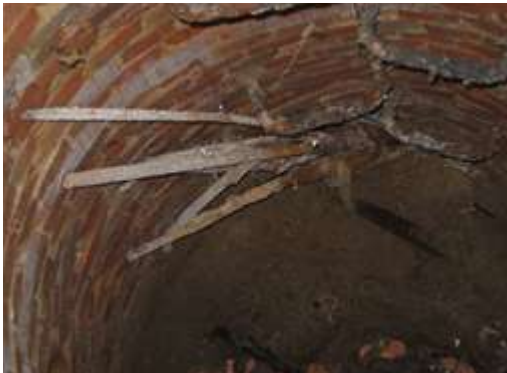
Defect 2

Poles

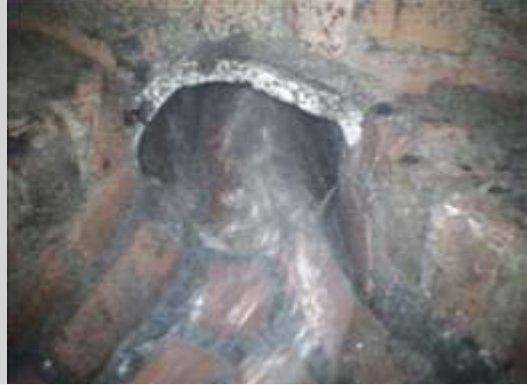
12 O'Clock Outflow

Pipe Height: **10.8** (in.) Rod and Bar (Angled)  
Pipe Material: **Clay** ☐ Pipe Lined  
Invert Depth: **12.61** (ft.) Flow Characteristics: **Fast**  
Deposits: ☒ None ☐ Mud ☐ Sludge ☐ Debris ☐ Grease  
Silt Depth: (in.) Deposits Extent:  
Infiltration: **None** Pipe Seal Cond: **Cracked**

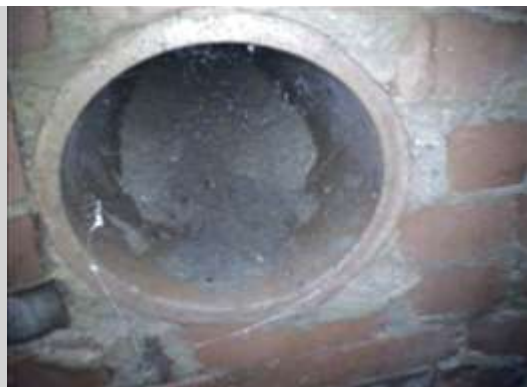
3 O'Clock Inflow

Pipe Height: **9.6** (in.) Rod and Bar (Angled)  
Pipe Material: **Clay** ☐ Pipe Lined  
Invert Depth: **7.49** (ft.) Flow Characteristics: **None**  
Deposits: ☒ None ☐ Mud ☐ Sludge ☐ Debris ☐ Grease  
Silt Depth: (in.) Deposits Extent:  
Infiltration: **None** Pipe Seal Cond: **Sound**

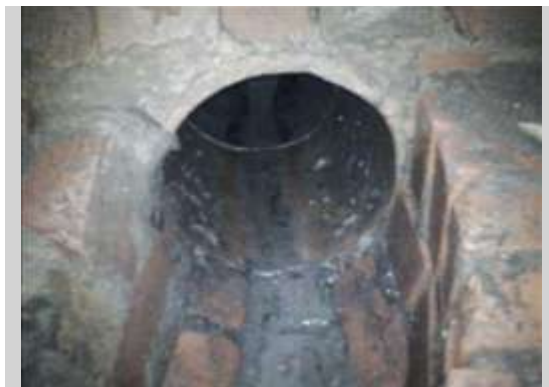
Drop In @ 3 O'Clock

Drop: **Outside** Rod and Bar  
Angled: **Yes** Reading: **11.01** (ft.)  
Inv Depth: **12.01** (ft.)  
Drop Condition: **Open**

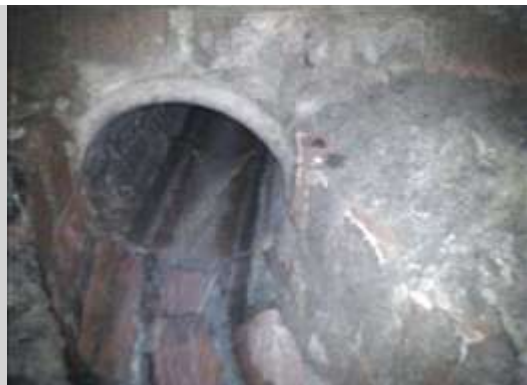
9 O'Clock Inflow

Infiltration: **None** Pipe Seal Cond: **Sound**
